# HackAP Hackathon – Power Distribution

## Problem Statements

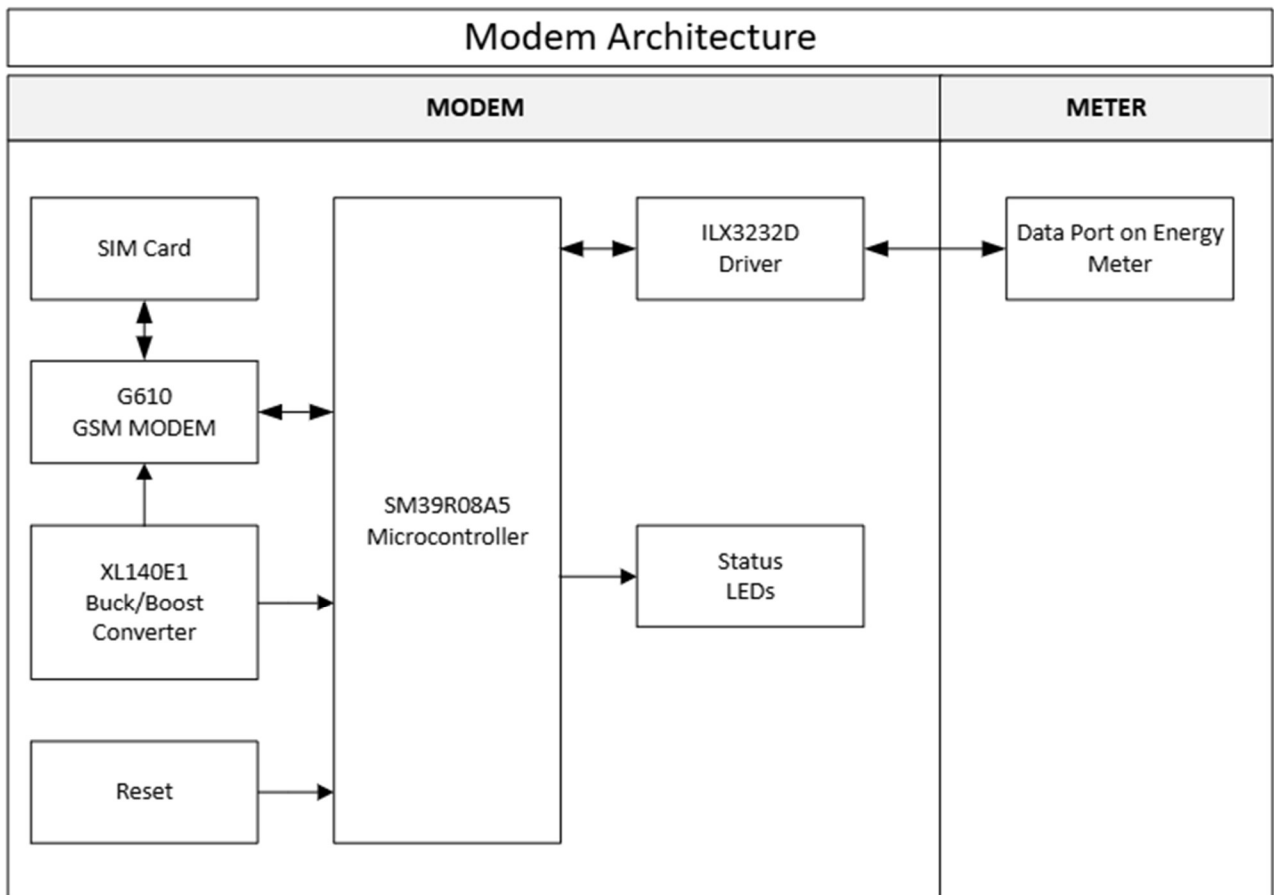
Block Diagrams:

There are 7,530 modems installed at HT Services and 11 kV Feeders to facilitate real-time communication of data with APEPDCL’s servers. However, it has recently been observed that the communication consistency of these modems is poor. This inconsistency adversely affects the efficiency of the Outage Management System (OMS) and leads to inaccurate reporting on the National Feeder Monitoring System (NFMS).

The Modem is also equipped with a 3.7V battery.

- Study the existing modems' Network Interface Card (NIC) firmware, rewrite the firmware on the existing hardware.
- Modify the data acquisition software (MQTT Protocol)
- Ensure the acquired data is integrated to the APEPDCL database.
- The solution must have a considerable impact on the communication consistency of the modems.
